**CONSIDERATION OF ADAPTIVE REUSE PROCESS WITHIN THE
CONTEXT OF ENERGY-EFFICIENT BUILDING DESIGN STRATEGIES:
THE EXAMPLE OF TRADITIONAL ŞANLIURFA HOUSE**

ÇANKAYA UNIVERSITY

**M.Sc. Thesis in
INTERIOR ARCHITECTURE**

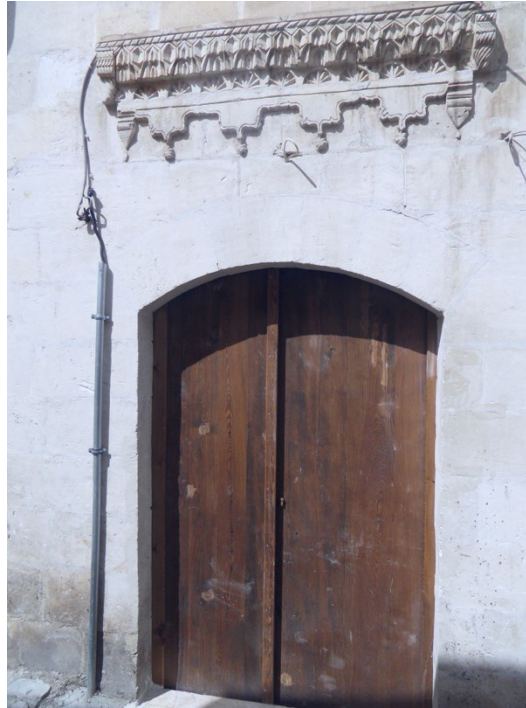
Figure 10: Entrance door (Tema 2008: 66)

Due to the social structure, it was preferred that their houses be close to the street. Usually, there are flat and high walls. The biggest opening of the building to the narrow streets is the arched stalactite entrance door (Figure 10). In addition, the main room of the selamlık section has an projection with a window facing the street. This projections is caused by overlapping made by the overlapping stone beams method. (Buyukmichi 2000: 56).

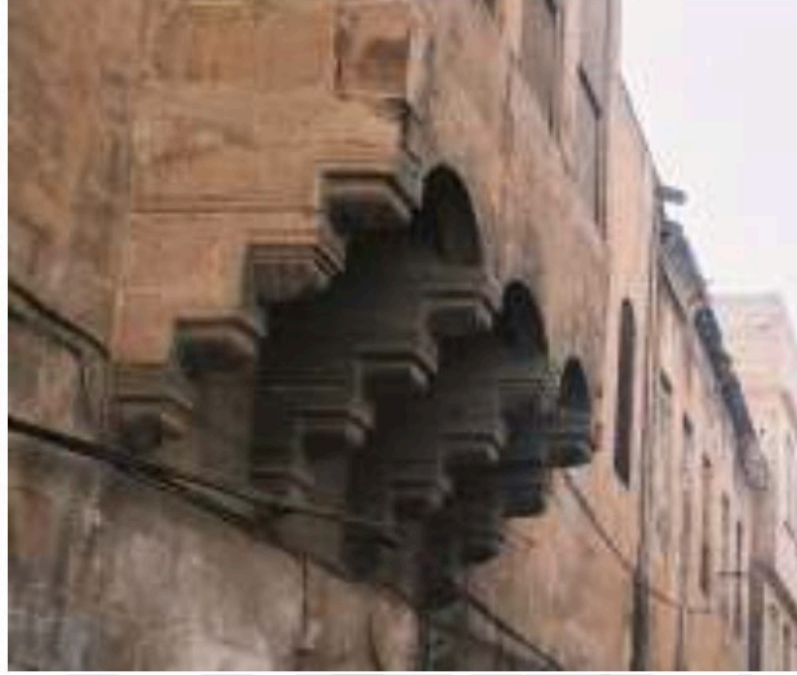
Figure 11: Projection (Turan 2009: 45)

The traditional construction technique used in buildings in the region is stone masonry with stone material. Volcanic limestone, locally called "havara" is the main material of the houses. The material is a soft and workable limestone. Ash-lime mortar, which is a mixture of havara powder, lime, and water, is used as a binder between the stones. A mesh system is created by filling 30-40 cm thick rubble between 15 cm thick cut stones on the bearing walls. The walls of the building are approximately 60-100 cm thick. The stones are cut into 24 cm sizes and 25 cm modules are formed by placing 1 cm of mortar in between. Stones are shifted to create an projection of more than 25 cm in the projections of the building (Figure 14).

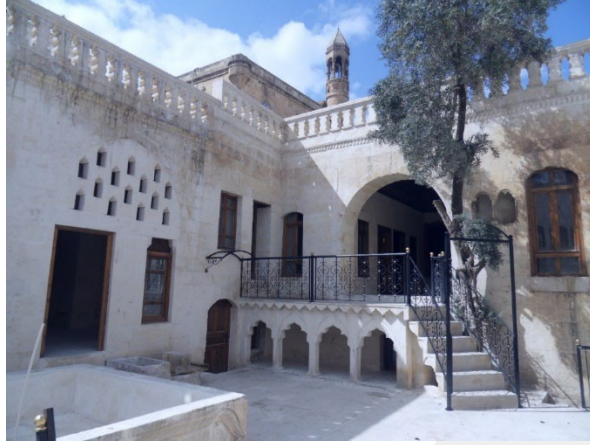
Figure 18: Nuran Elçi mansion courtyard north and west facades (TEMA 2008: 23)

There are windows in all rooms, including the rooms on the basement floor, from the courtyard front. There are overhead openings on the courtyard facades to provide air circulation in the kitchen and rooms. The overhead openings in the kitchen area are planned as larger and more numerous depending on the function of the space. Figure 19 In the image of Nuran Elçi Mansion Courtyard North and West, the hill openings overlooking the courtyard from the kitchen are seen. No material was used in these openings and they were left completely open. As seen in Figure 18, the windows are wooden framed and the doors are wooden.

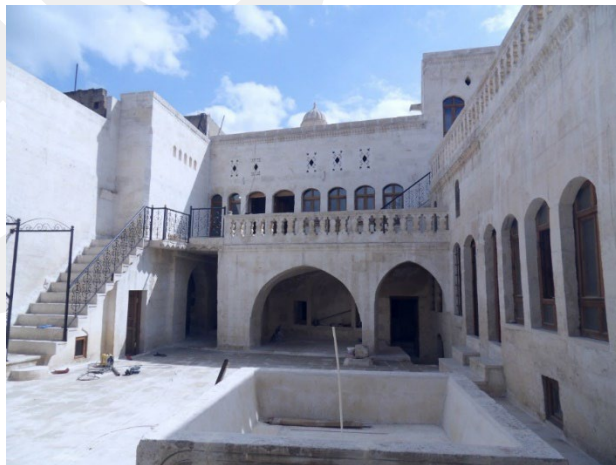
Figure 19: Nuran Elçi Mansion courtyard south and west (TEMA 2008: 24)

There is a pool in the courtyard to increase humidity and cool down. In addition, the muqarnas and the balustrades seen on the facades of the terraces and terraces facing the courtyard in the building are of the type frequently seen in traditional Urfa houses. The balustrades and muqarnas are also made of chipped stone (limestone) material used in the building itself. Figure 19. In the image of Nuran Elçi Mansion Courtyard South and West, the pool in the courtyard, the walkways, and the balustrades and muqarnas on the terraces are seen. In addition to this, the overhead openings of the selamlık rooms on the 1st floor can be seen in Figure 19. It is smaller and more ornamental than the overhead openings seen in the kitchen space before. In the same image, the windows of the zerzembes located on the basement floor on the west facade are also seen.

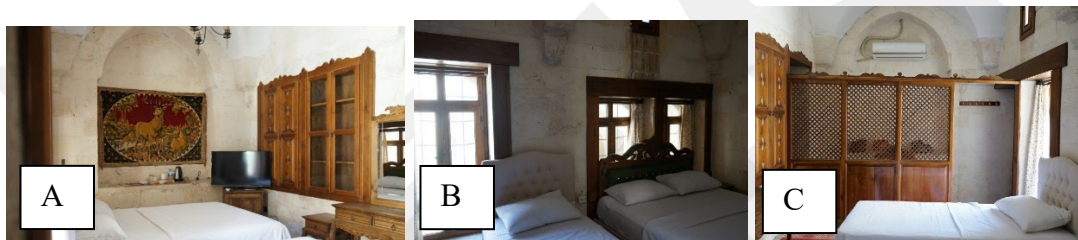
SPACE 1- G1 (Room): It was planned as an oriental room according to the restoration project, but today it is used as a bedroom. The room has no window and door openings other than the courtyard. It has a cross-vaulted ceiling, 3 windows, and 2 skylights. Limestone, which is the building material, was left as it is in the remaining areas where plaster was applied on the ceiling in the interior. Artificial lighting in the room is provided by a ceiling chandelier (fluorescent bulb). A split air conditioner is used for heating and cooling the room. The visuals of the room are shown in Figure 40 Room G1. The plan of the room and the division made for the lighting measurement during the measurement can be seen in Figure 41 G1 Room Plan image.

Figure 40: G1 Room Photos (A,B,C) (Photo by Author)

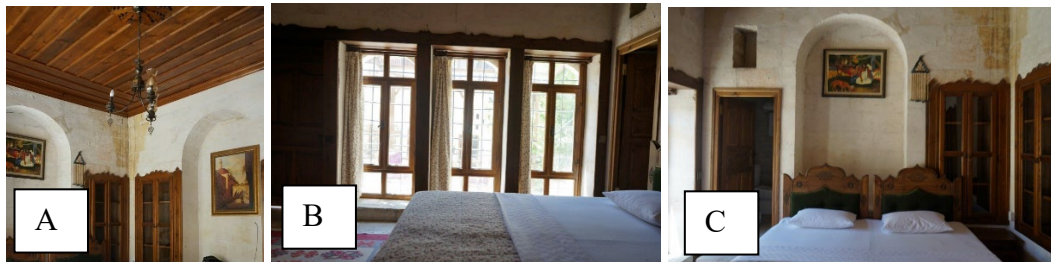
Figure 42: G9 Room Photos (A,B,C) (Photo by Author)

42 Figure G9 Room photos. The plan of the room and the division made for the lighting measurement during the measurement can be seen in Figure 43 G9 Room Plan visual.

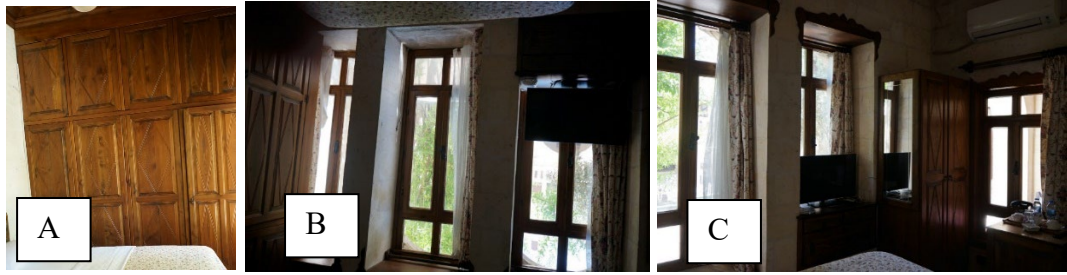
SPACE 4 – G7 (room): The room is now used as a bedroom. Unlike the other rooms, it has a window opening to the northern iwan in addition to the 3 windows opening to the courtyard. The door of this room also opens towards the iwan, not the courtyard. The windows to the courtyard are flat and low to the ground. In addition to the wood veneer ceiling, the east façade wall is also wood veneered. Artificial lighting in the room is provided by a ceiling chandelier (fluorescent bulb). A split air conditioner is used for heating and cooling the room. Images of the room are shown in Figure 46. The plan of the room and the division made for the lighting measurement during the measurement can be seen in Figure 47 G7 Room Plan visual.

Figure 46: G7 Room Photos (A,B,C) (Photo by Author)

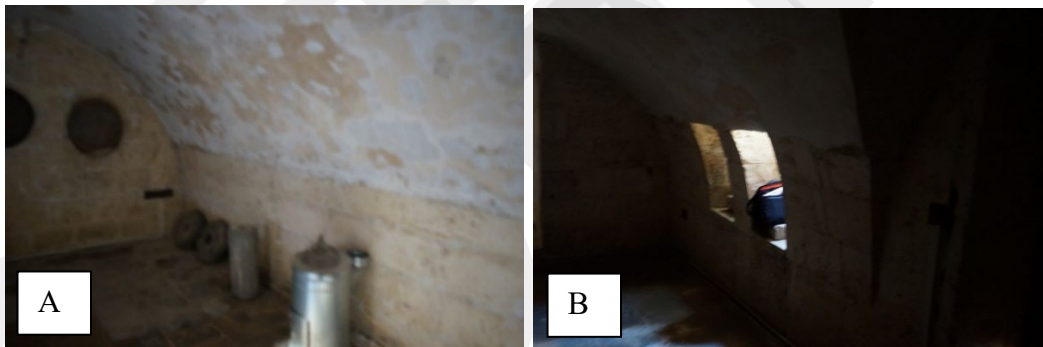
Its vaulted ceiling was covered with Khorasan plaster in 2008 (TEMA 2008: 56). Artificial lighting in the room is provided by a ceiling light fixture (fluorescent bulb). Active systems for heating and cooling are not used in the room. Images of the room can be seen in Figure 49 Room B1 photos. The plan of the room and the division made for the lighting measurement during the measurement can be seen in Figure 50 B1 Room Plan image.

Figure 49: B1 Room Photos (A,B) (Photo by Author)
