**ADAPTIVE RE-USE OF HISTORICAL HERITAGE BUILDINGS:  
ASSESSMENT OF FOUR HAMAMÖNÜ HOUSES  
AND MORE EMPHASIS ON INTERIORS**

A THESIS SUBMITTED TO  
THE GRADUATE SCHOOL OF NATURAL AND APPLIED  
SCIENCES OF  
ÇANKAYA UNIVERSITY

IN PARTIAL FULFILLMENT OF THE REQUIREMENTS FOR THE  
DEGREE OF  
MASTER OF SCIENCE  
IN  
INTERIOR ARCHITECTURE  
DEPARTMENT

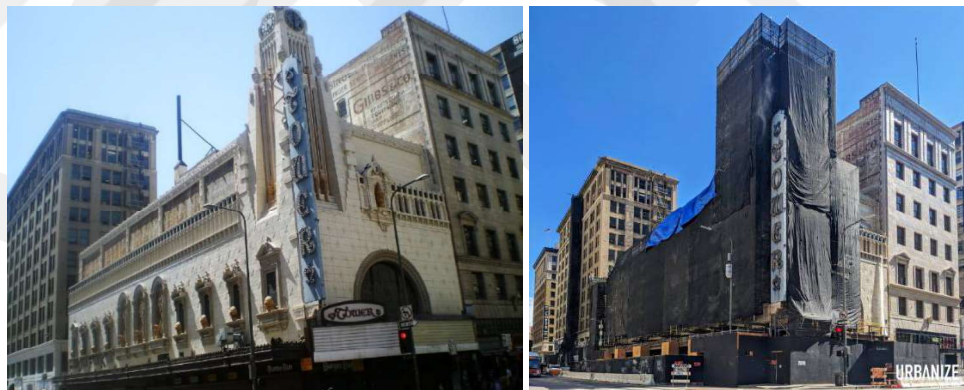
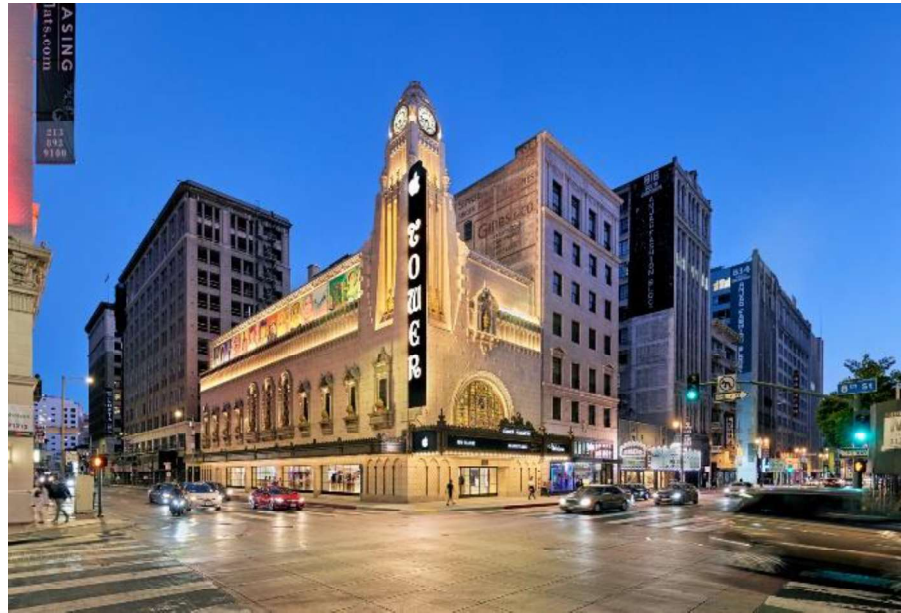
**Figure 1.** The Apple Store Buildings  
Facade View (Url, 1)

Designed in 1927 by prolific motion picture theater designer, S Charles Lee, Tower Theatre was the first movie theater in Los Angeles built to show talking movies. The design restores the distinctive clock tower and exterior terracotta facades, enhances historic interiors and improves the marquees and the Broadway Street elevation, while upgrading accessibility to ensure the building will survive and serve the community long into the future.

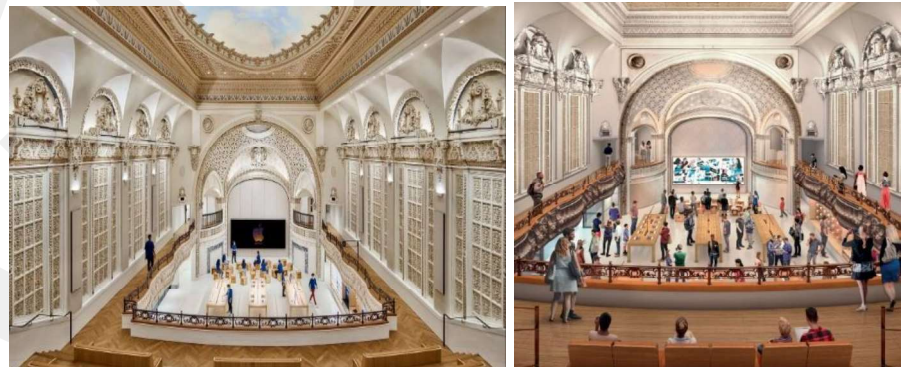
**Figure 2.** The Apple Store Buildings  
Interior Design Transformation (Url, 1)

The design looks to create an active presence on Broadway. Visitors enter a generous lobby at street level. An immaculately restored grand staircase takes visitors to the upper levels, while the lobby opens up to the soaring volume of the main theatre hall at ground level, which has been completely transformed into a majestic display area. The intricate historic plaster detailing on the walls and ceiling, dating back to the 1920s, has been carefully restored and enhanced. The central dome of the theater's ceiling has been reinterpreted with a fresco of the calming golden sunshine of the southern Californian sky, adding dynamism and color to space.

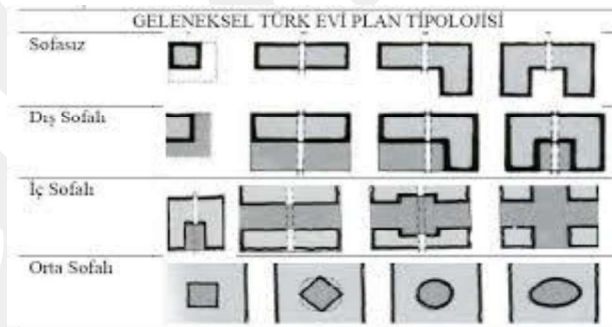
**Figure 10.** The Traditional Turkish Plan Types Typology  
(Eldem 1972, Eldem 1986)

- a. Plan Type Without Sofa
- b. Plan Type With Outer Sofa
- c. Plan Type With Inner Sofa
- d. Plan Type With Central Sofa

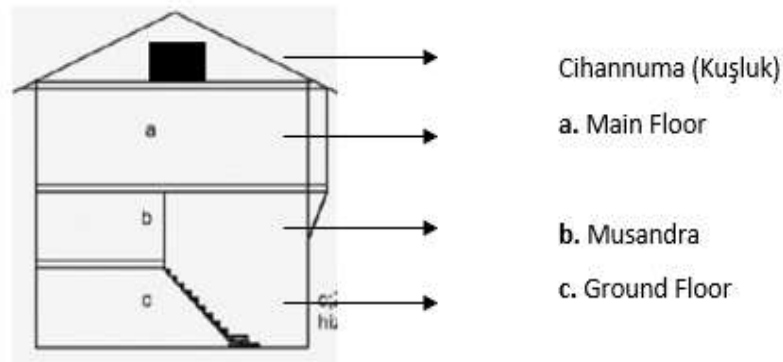
The condition of the land where the house is located is important, the floor has been raised to allow the main floor to receive more air, light, sun and to widen the viewpoint according to the condition of the land. In two-floor buildings, the ground floor isn't used to sit. The ground floor is used for service areas in which case the reflection of the floor to the facade is quite plain. This floor has pylons that carry the building and consist of garden walls.

**Figure 11.** Section plan Typical Ankara House  
(Author's Archive, 2021)

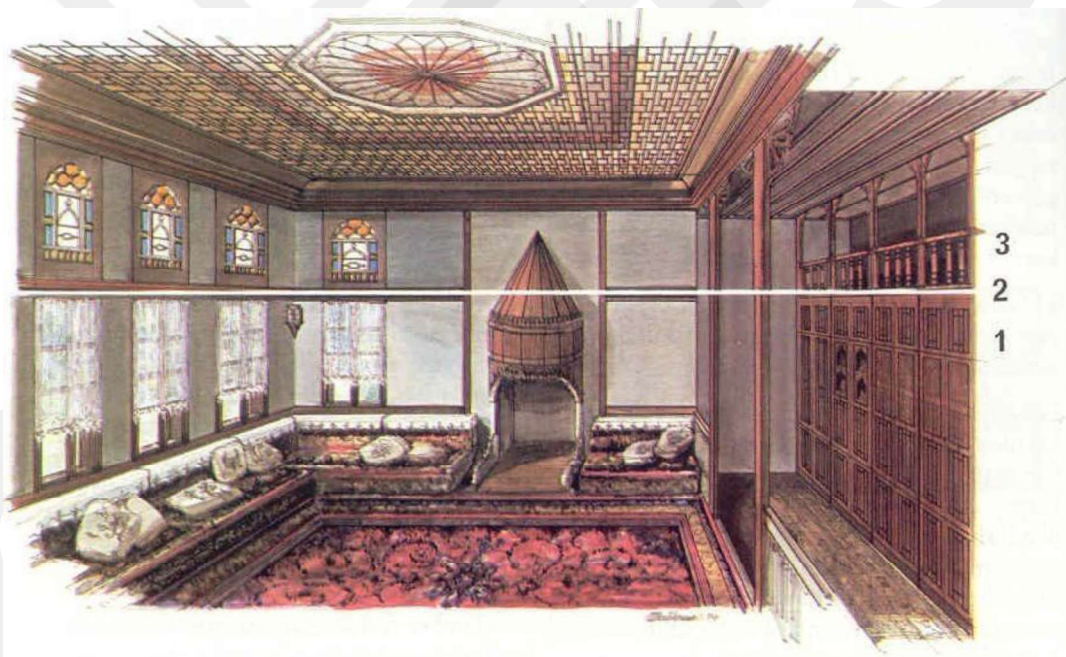
In the rooms of traditional Turkish houses, dimensions, heights and decorations are created in an order. The rooms aren't designed too large for the room to hold heat, and the heights aren't made too high for the room to hold heat. At the same time, there are 3 sections in the organization of the room in the horizontal direction in the Turkish House. (Küçükerman, 1988)

**Figure 12.** “Beneficial space” limit of Turkish house room (Küçükerman, 1988)

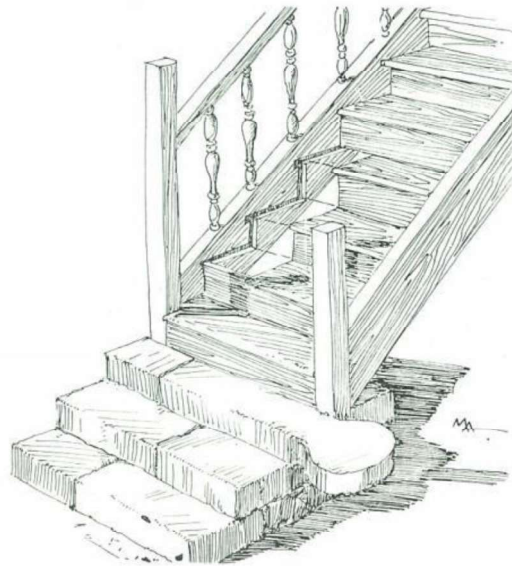
Stairs were generally applied with straight arms. At some times, the stairs are designed in the form of two arms with a pitch or “L” with a corner pitch. In some traditional houses, three-armed houses were built. Some of the traditional houses didn't use railing on the stairs because there are wooden curtains on one side of the staircase and on the other side of the wall. The materials of the railing in the houses are designed in stone, wood or iron. (Altun, 2008)

**Figure 16.** Stairs Detail (Kuban, 1954)

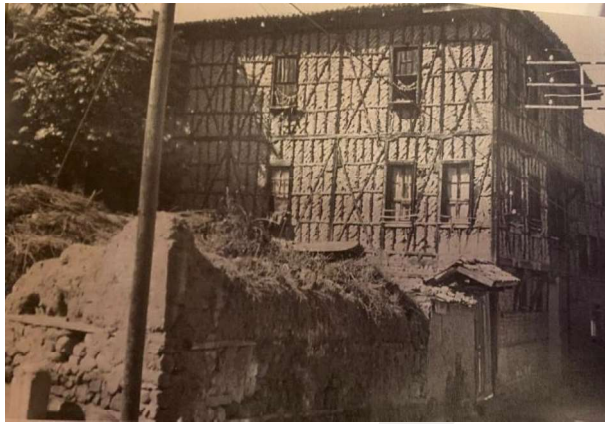
**Figure 21.** Osmaneli (Kuban, 2018)

In all regions, the use of rubble stone on the ground floor of a Turkish house is a common method. Wood was used for horizontal and vertical load bearing elements in the upper floors of the house. In the wall, a wooden stretcher was widely used. Adobe has always been used in the filling material. All trees such as pine, oak, chestnut, hornbeam, juniper, Sedir ( Settle Type of Siting) and poplar were used in house construction. In richer houses, oak, chestnut and Sedir ( Settle Type of Siting) materials were used as trees. Especially poplar was used as material on the roofs of Central and Central South Anatolia. (Kuban, 1995)

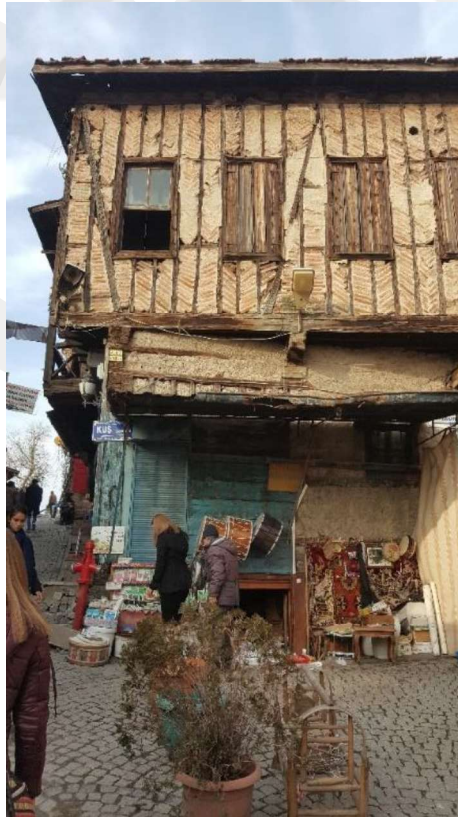
**Figure 23.** Ankara Castle Region, Ankara House Timber Framed- Brick Infill in Herring Bone Pattern (Author's Archive, 2020)

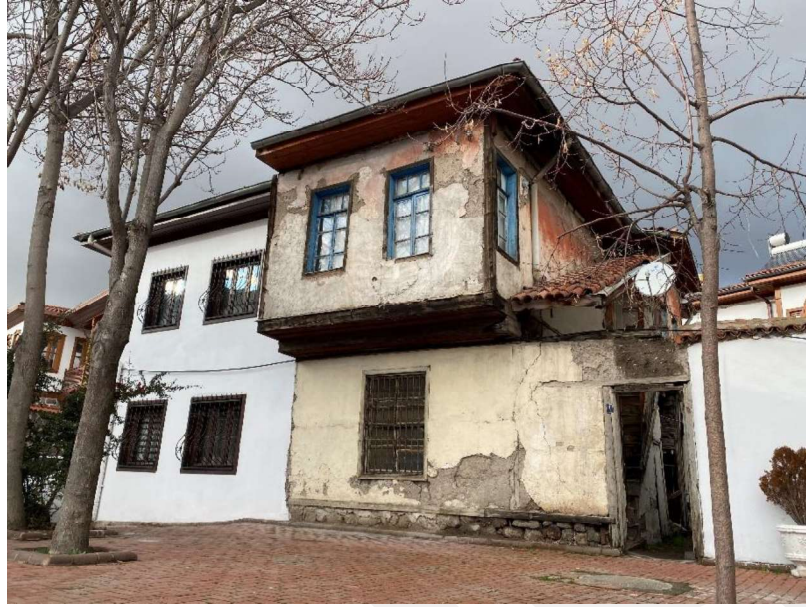
**Figure 24.** Hamamarkası Region, New and Old Buildings Side By Side  
Bay Window, Eaves, Stone Floor, Tile Cover, Window Iron Railing  
(Author's Archive, 2021)

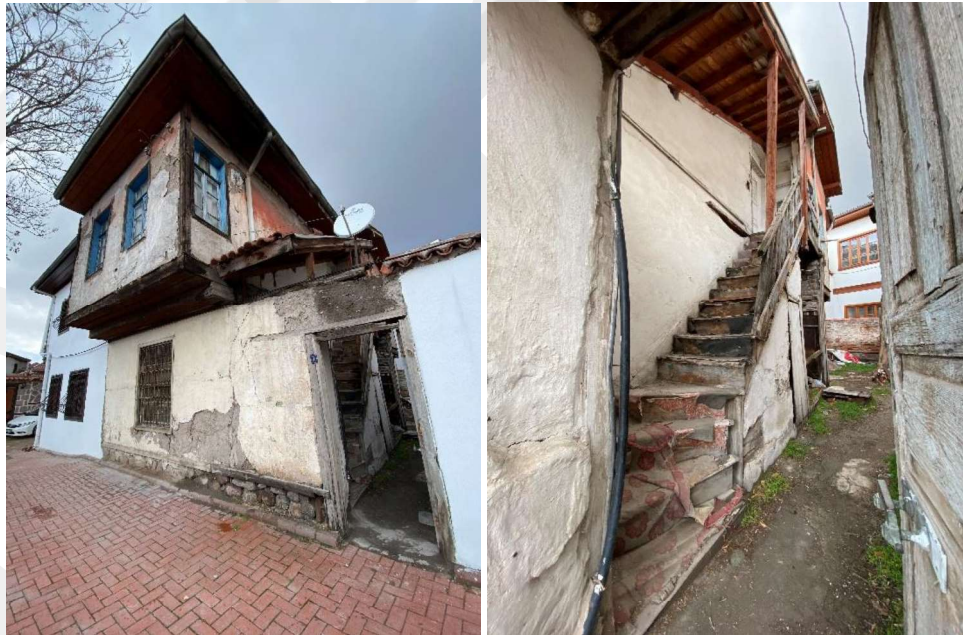
**Figure 25.** Hamamarkası Region, Views of the Old Building  
Bay Window, Court, Stairs, Wood Pole, Eaves, Gutter (Buildings In Upper Photo)  
(Author's Archive, 2021)

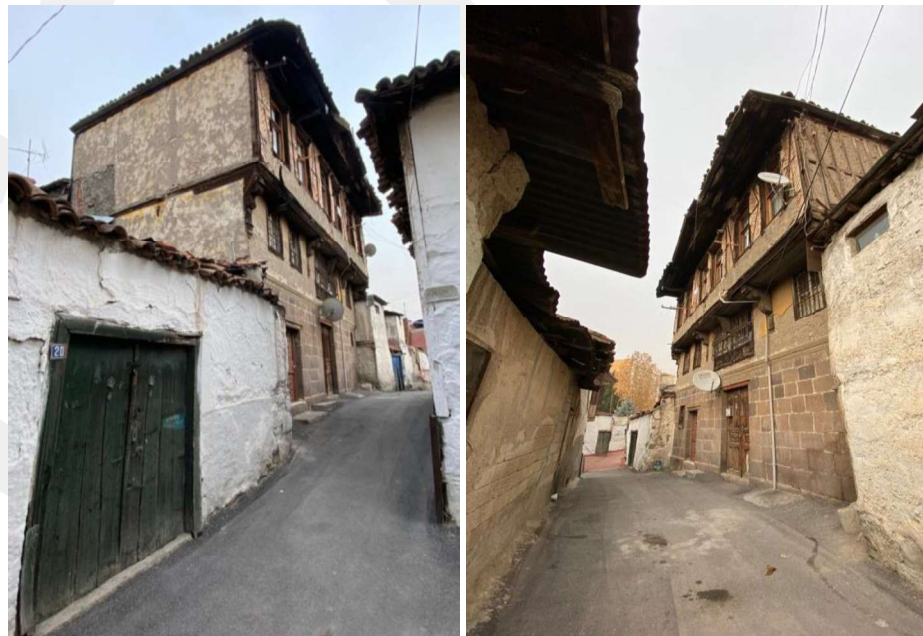
**Figure 31.** Hamamarkası Region, Old Ankara House)  
Ankara House and Mezzanine Floor and From End to End Cantilever  
(Author's Archive, 2021)

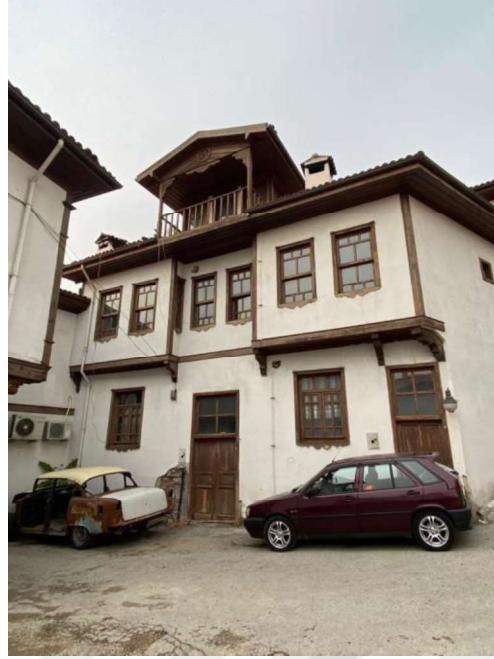
**Figure 33.** Hamamönü Region, Example of Cihannuma In Ankara House  
(Author's Archive, 2021)

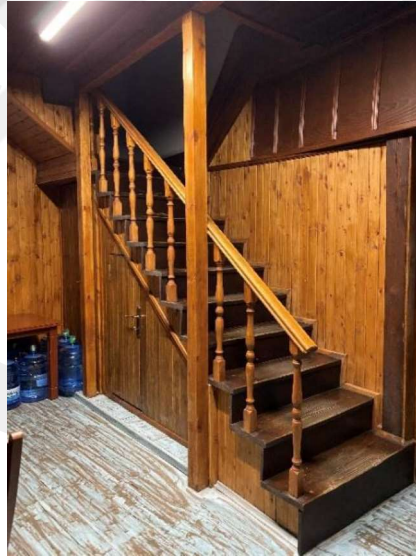
**Figure 35.** Hamamönü Region, Türk Kızılay Youth Center Building Street Rehabilitation Project Implementation Buildings Wood Staircase, Railing  
(Author's Archive, 2021)

Hanging stairs lead to a large covered terrace or to a sofa / Divanhane or terrace located between the rooms of the upper floor. The sofa of the House provides the function of seeing the large courtyard of the house or the wide view of the district. Inside the sofa or terrace, there are parts called Seyregah (Zigâh) that are built high in the form of a balcony. For houses that don't see the landscape well, balconies called

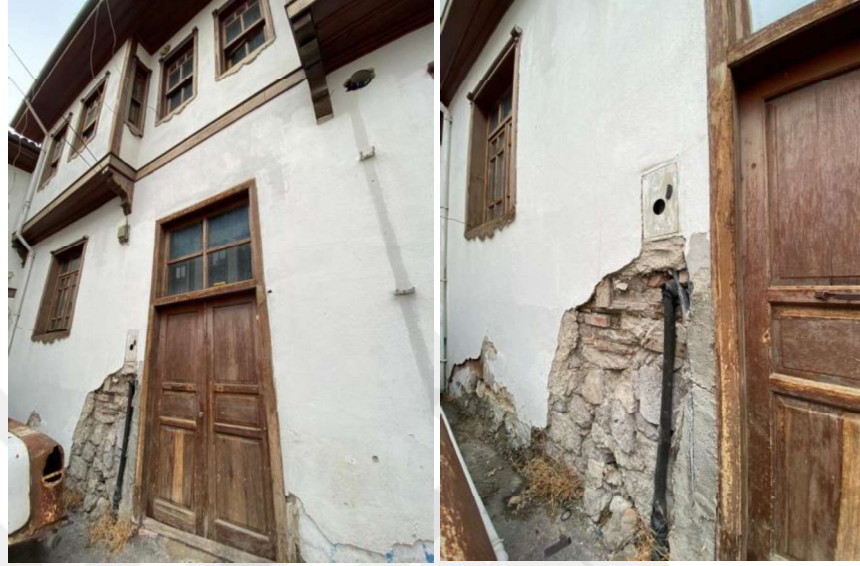
As in Anatolia, material selections in Ankara houses were selected according to seasonal conditions. In Central Anatolia and Ankara, where rainfall and forest cutting are low as a climate, the most basic building materials are stone and soil.

**Figure 39.** Hamamönü Region, Ankara House Stone Material, Simple Console Projection, Windows, Eaves, Entrance Door and Top Window  
(Author's Archive, 2021)

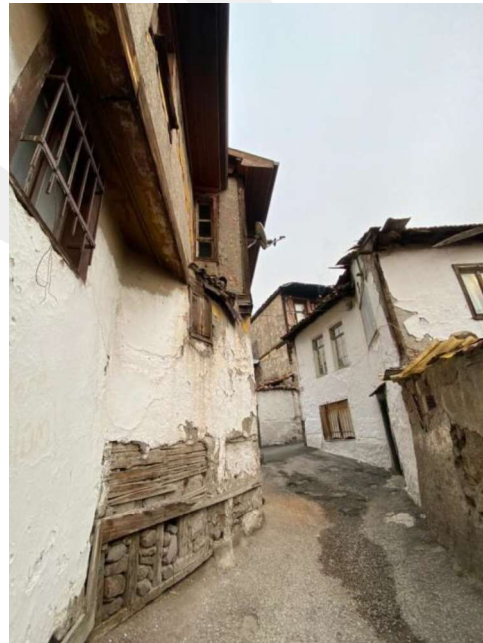
**Figure 40.** Hamamönü Region, Ankara House Stone Material, Railing, Projection, Eaves, Street Buildings  
(Author's Archive, 2021)

When looking at the building material and workmanship of the old Ankara houses, the foundation walls of the House are widely braided with stone. In some Ankara houses, the height level of these stone walls is up to the height level of the first floor. In some houses, this material was applied as adobe instead of stone. Parts of the walls, which are wide stone and adobe, are sometimes çatk1 with trees and hat1ls. The upper floor walls of the house were covered with thick adobe in some houses and in some houses with tree çatk1 nogging. Thick adobe walls on the upper floors are connected by tree belts. In some houses, between the nogging çatk1, they were built with thin and flat bricks. In some buildings, it can be seen that nogging braids are made with adobe. (Akok, 1951)

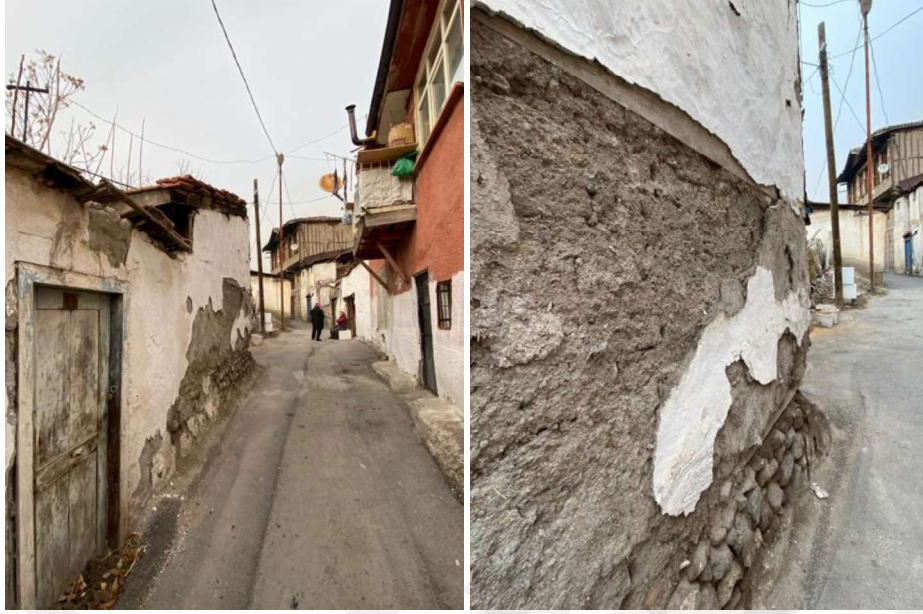
**Figure 41.** Hamamönü Region, Ankara House In Ruins  
Stone Material, Courtyard Door, Street Buildings  
(Author's Archive, 2021)

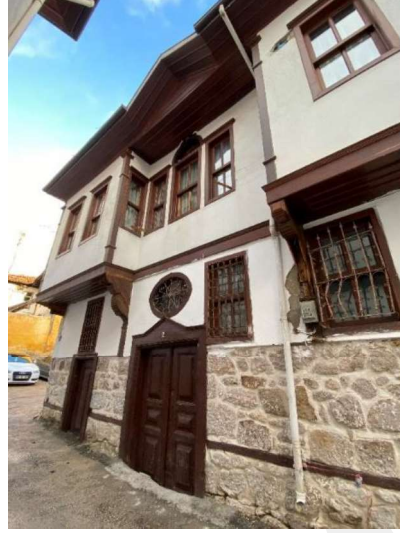
**Figure 42.** Hamamönü Region, Ankara House /  
Application of Westernization period of the 19th and 20th centuries  
Stone Ground, Mezzanine Floor, Simple Console Cumba ( Bay Window), Eaves, Iron  
Railing Window, Street Door, Door Top Elliptical Window, Floor Wiping, Gutter  
(Author's Archive, 2021)

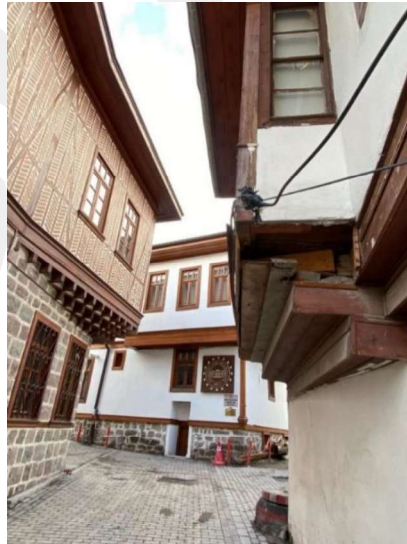
**Figure 43.** Bay Window Types  
Street Rehabilitation Project Implementation Applied Buildings And Street  
Hamamarkası House / ( Author's Archive, 2021)

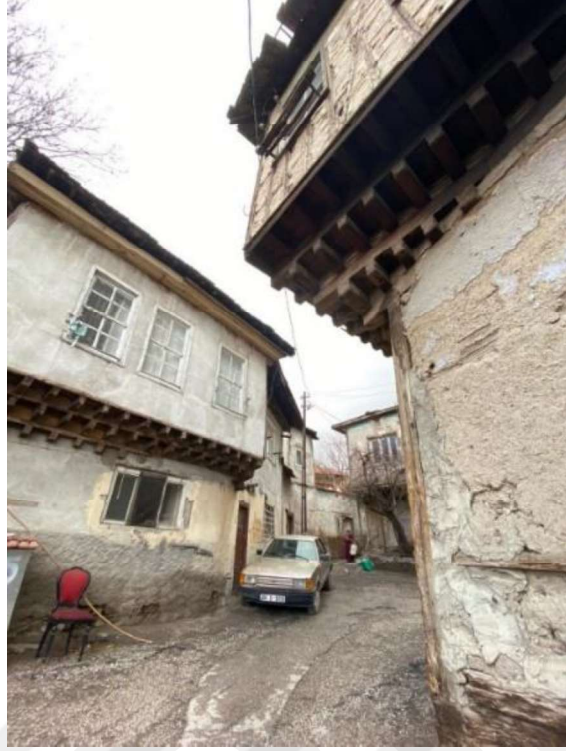
**Figure 44.** Traditional Ankara Houses, 3-Step Corbelling Projection Examples  
Hamamarkası Houses (Author's Archive, 2021)

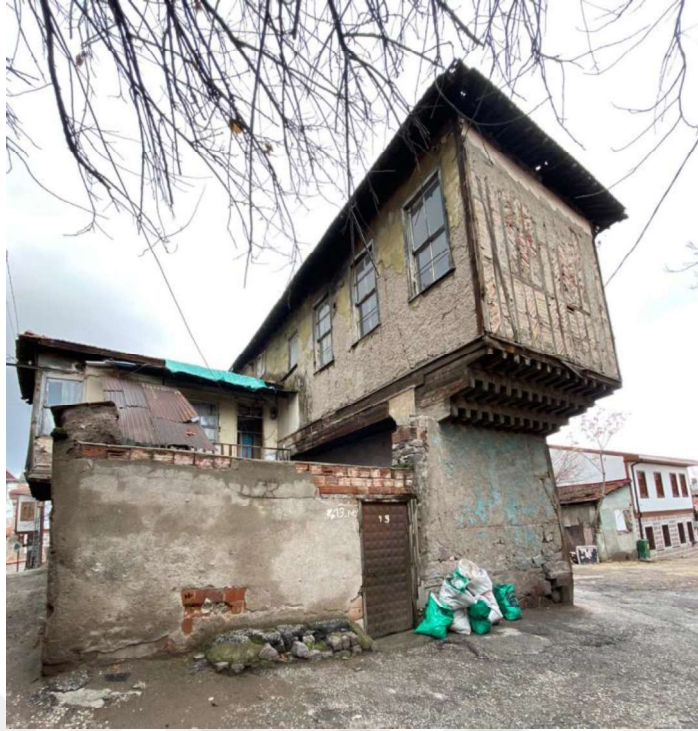
**Figure 46.** Ankara Hamamarkası Region, 3-Step Corbelling Bay Window  
(Buildings Photographed By Tuncer, Figure x.y)  
(Author's Archive, 2021)

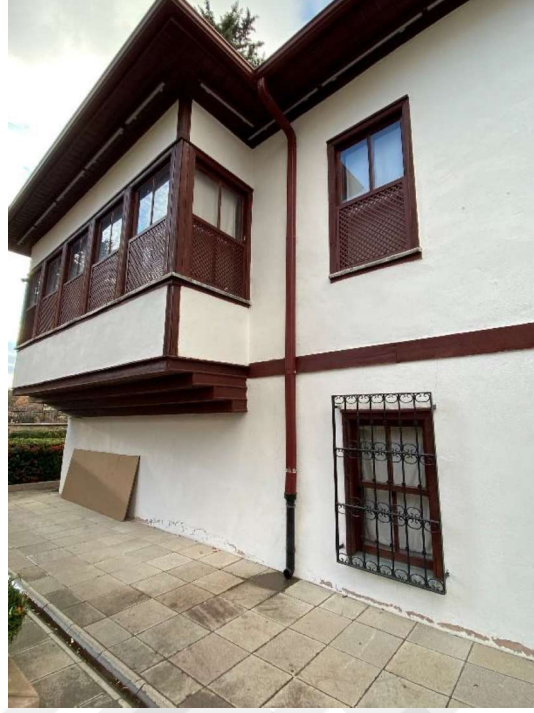
**Figure 48.** Hamamönü Region, Mehmet Akif Ersoy House Museum  
Street Rehabilitation Project Implementation  
Wood Lattice, (Author's Archive, 2021)

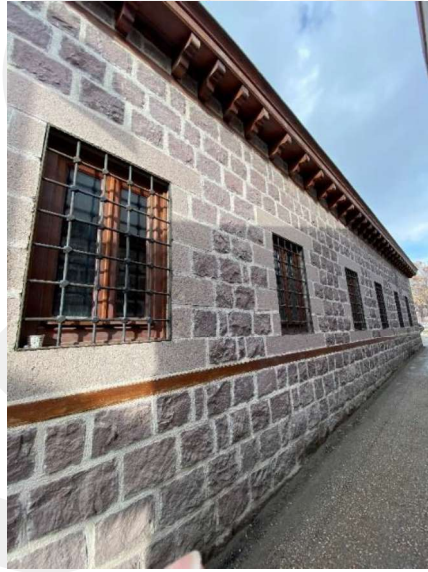
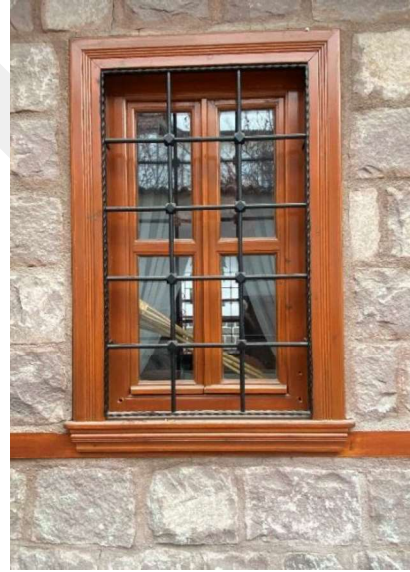
**Figure 49. a.** Hamamönü Windows / Iron Bar Railing  
**b.** Hamamarkası Windows / Iron Bar Railing  
Street Rehabilitation Project Implementation  
Hamamönü Region Car Park Road  
(Author's Archive, 2021)

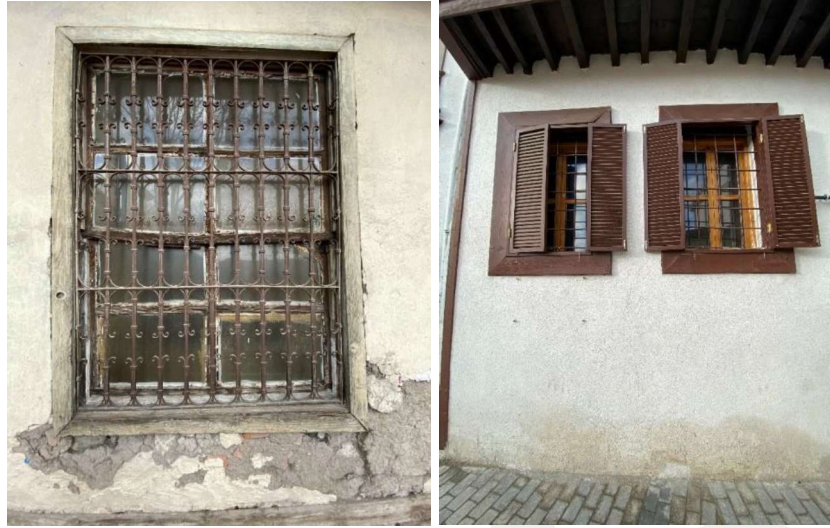
**Figure 50. a.** Decorations of Iron Grating on The Windows of Ankara House Hamamarkası, Figure 27 Window of The Building  
**b.**Hamamönü Windows / Iron Bar Railing, Shutters of Example  
 (Author's Archive, 2021)

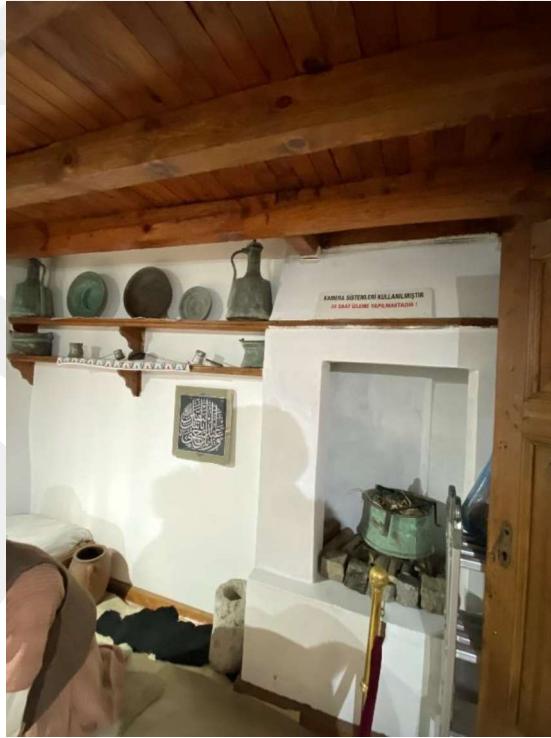
**Figure 51.** Hamamönü Region, Mehmet Akif Ersoy House Museum  
 Fireplace, Terek Elements (Author's Archive, 2021)

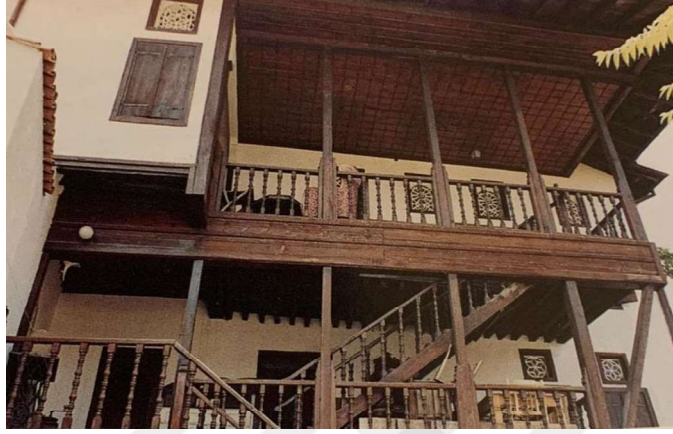
**Figure 52.** “Hayat” in Ankara House (Tuncer, 2002)

“*Hayat-ı*” open sofa was placed instead of the most beautiful and scenic part of the house. The Hayat element is an important element for Ankara houses and is connected with the courtyard.

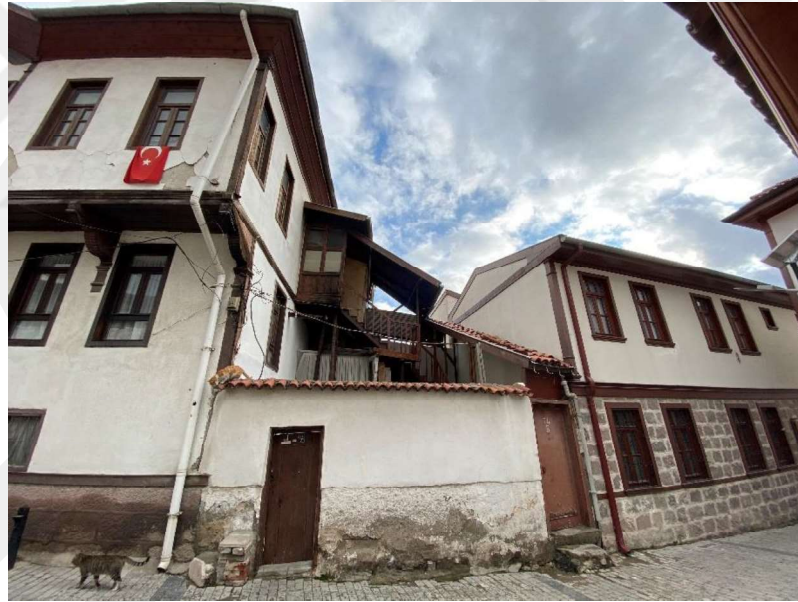
**Figure 53.** Hamamönü Region, Ankara House Courtyard  
(Author’s Archive, 2021)

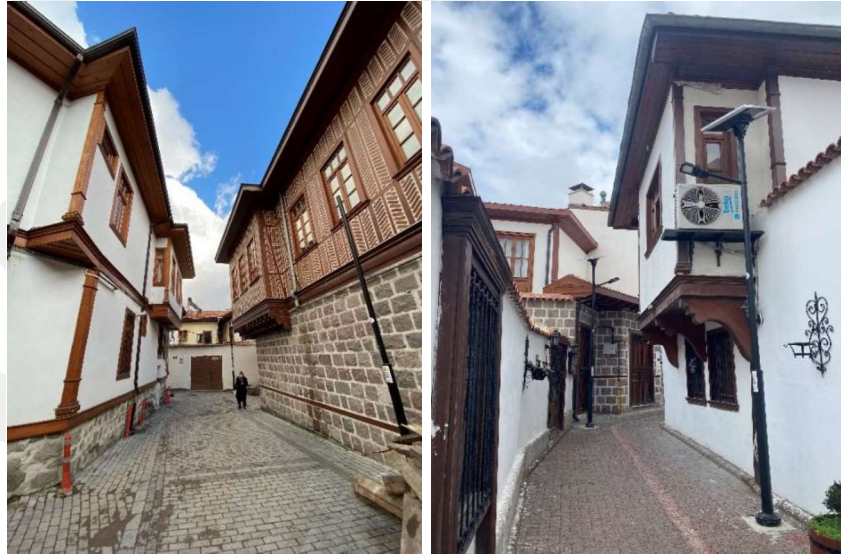
**Figure 60.** Hamamarkası ve Hamamönü Region  
Street Rehabilitation Project Implementation  
(Author's Archive, 2021)

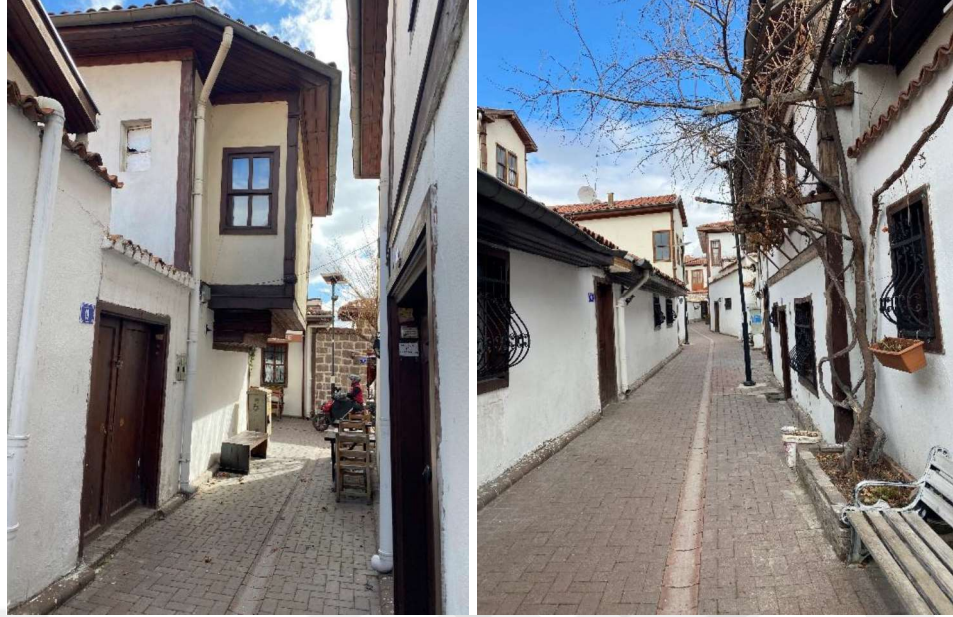
**Figure 61.** Hamamönü Region, Fırın Street  
Street Rehabilitation Project Implementation  
(Author's Archive, 2021)

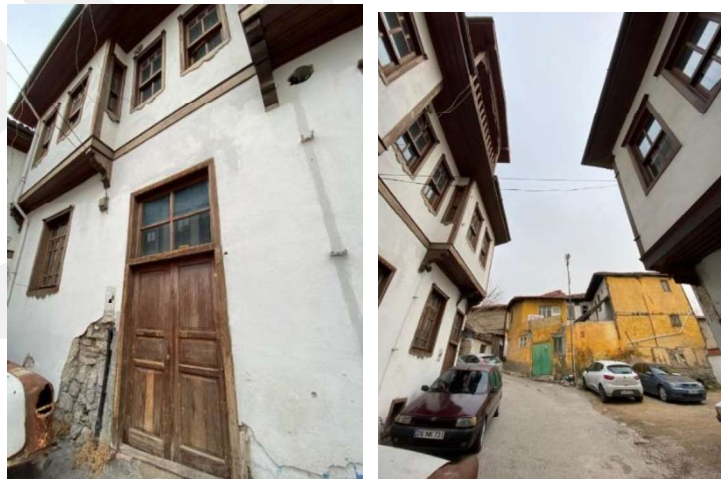
**Figure 89.** The Ruined Houses of Hamamönü, 2021 (Author's Archive)

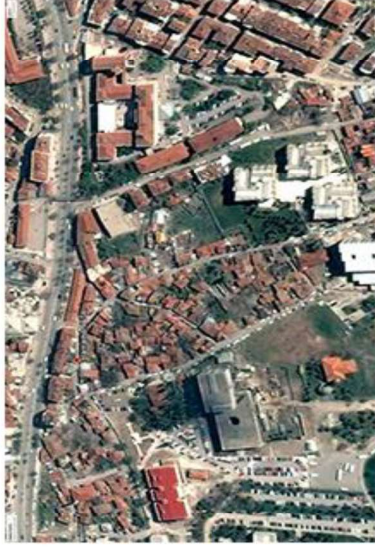
- 2002 Year

- There are buildings in the place of the Clock Monument / Square.
- The roof of Karacabey mosque is previously covered with tile.

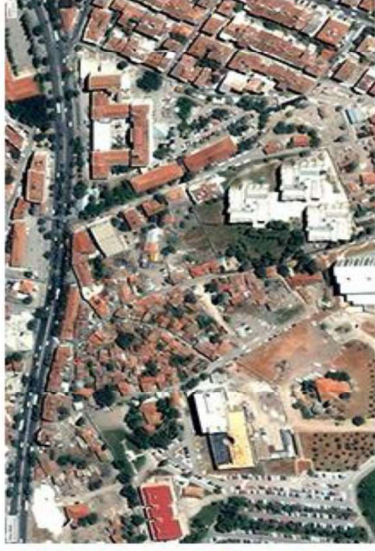
- 2004 Year

- Environmental regulations have started at the Hacettepe University and in the region.

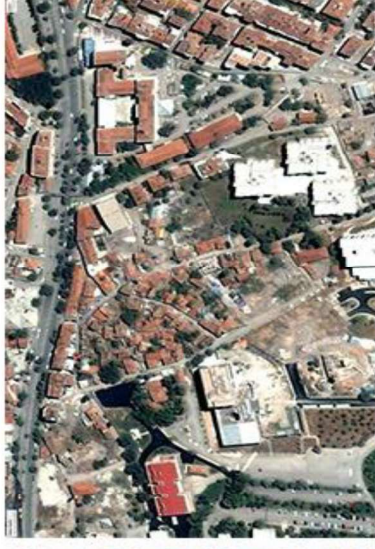
- 2005 Year

- The Karacabey Mosque and its roof have begun to be repaired, and the surrounding of the mosque has begun to be renewed.

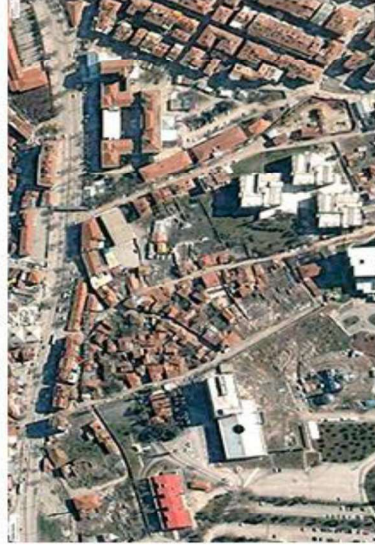
- 2006 Year

- A street Rehabilitation Project has started to be applying in the region. First of all, project work has started on Dutlu Street and İnci Street.

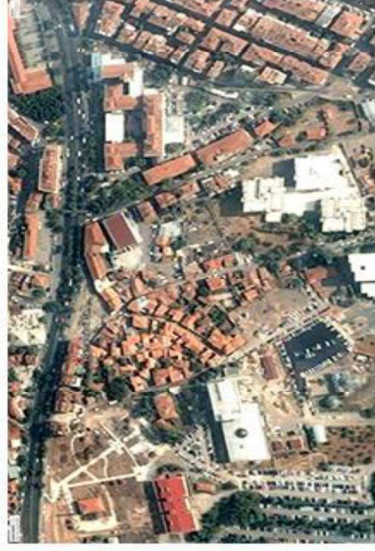
- 2007 Year

- The "Square Area" has been organized.

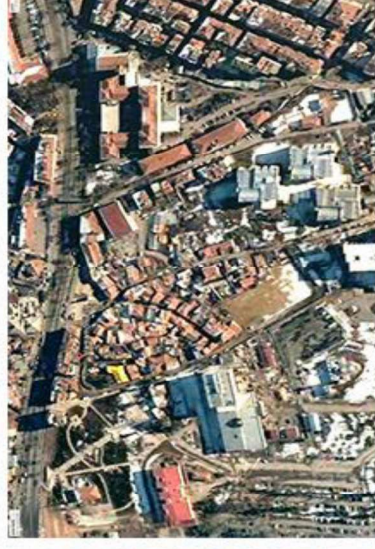
- 2008 Year

- The spirit of the Square was renewed with the settlement of the Clock Monument.
- Environmental organized has been provided in the University, Park and area.

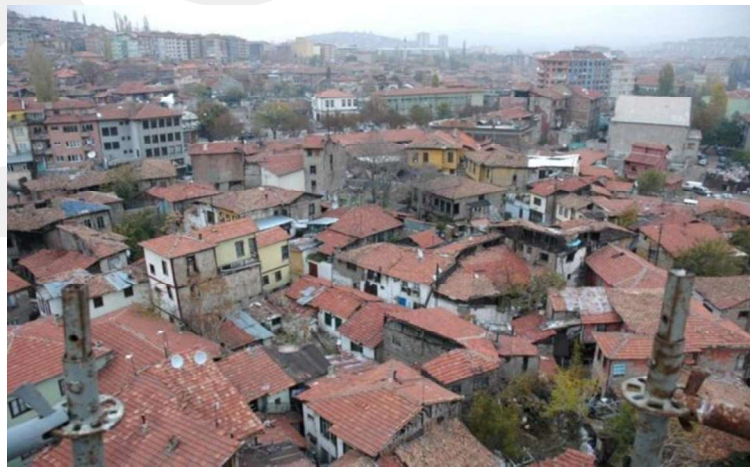
**Figure 90.** A Section Belonging to the Hamamönü Region in 2008 (Altındağ Municipality, 2014)

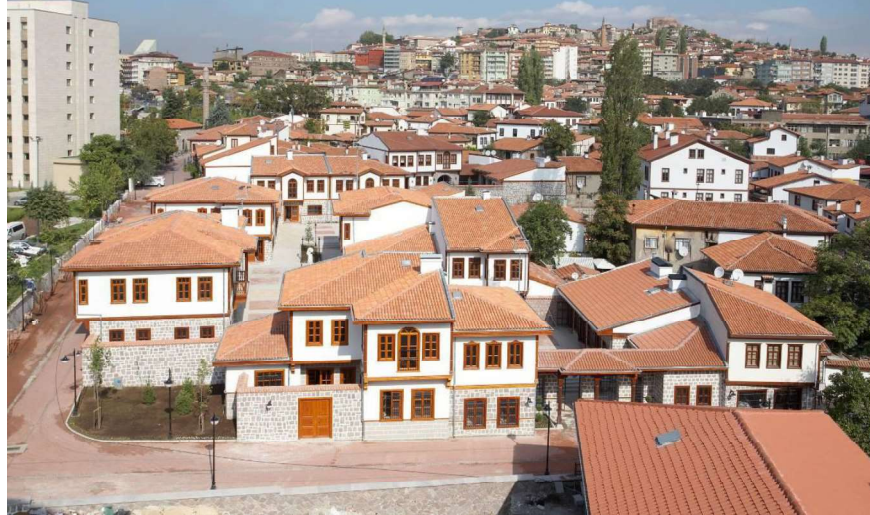
**Figure 91.** A Section of Hamamönü Region in 2012  
(Altındağ Municipality, 2014)

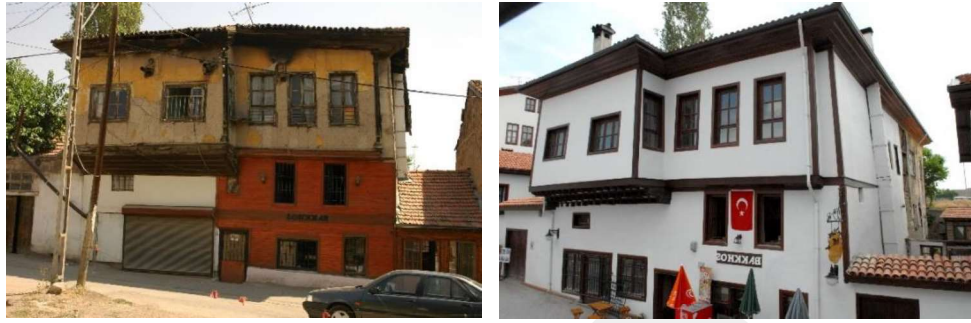
**Figure 98. a.** Before Reconstruction Hamamönü House, Sarıkadı Street  
**b.** After Reconstruction Hamamönü House, Sarıkadı Street

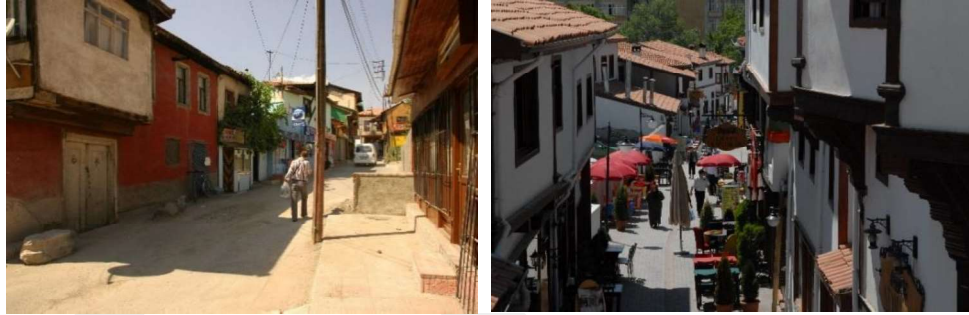
**Figure 99. a.** Before Reconstruction Hamamönü House, Sarıkadı Street  
**b.** After Reconstruction Hamamönü House, Sarıkadı Street

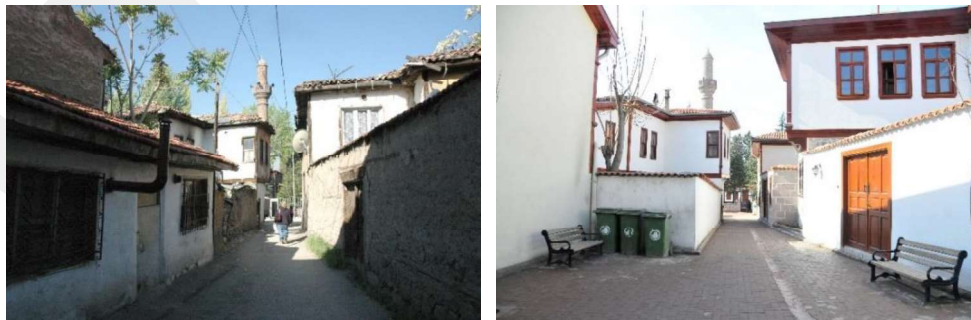
**Figure 100. a.** Before Reconstruction Hamamönü House, Fırın Street  
**b.** After Reconstruction Hamamönü House, Fırın Street

In the restoration works carried out in the hamamonu, more facades were studied. When the streets of the region that exist today are analyzed, especially when the Fırın street is examined, only exterior works have been done in the buildings, but no interior works have been observed.

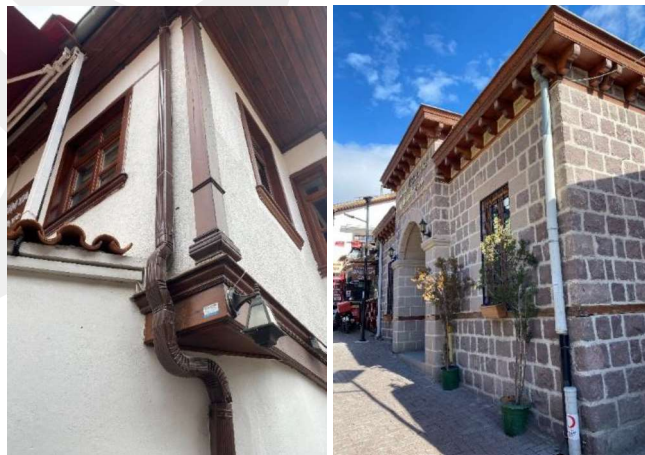
**Figure 109.** Façade Pipes, 2021  
(Author's Archive)

During the restoration process, new chimneys were built outside the buildings to minimize the damage caused to the area by the stovepipes on the street.

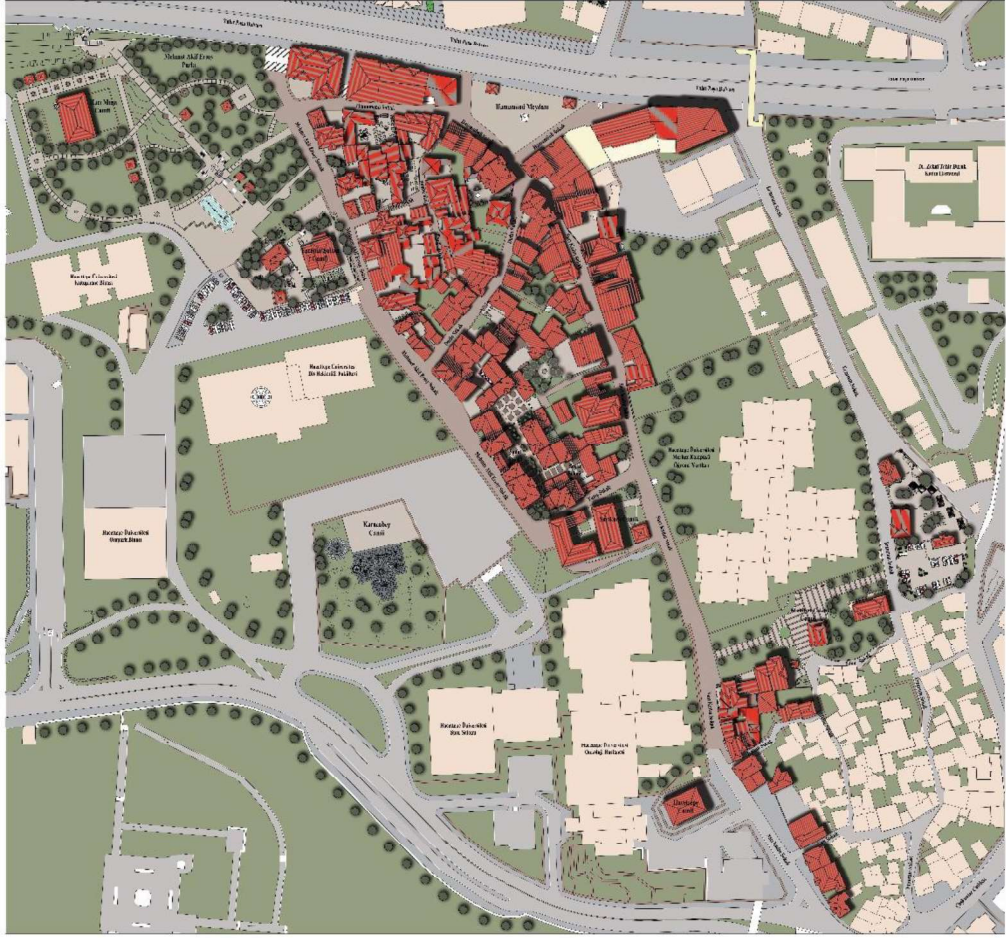
**Figure 118.** Hamamönü District Site Plan, 2013-2014 & 1/700  
(Altındağ Municipality Historical, Areas Conservation Branch, 2020)

For this section, first of all, a detailed research and investigation was carried out in the study area / Hamamönü. The research was designed and made in the context of certain rankings. (Chapter 3) After the completed researches, a plan study was carried out within the scope of the use type and land conditions of the existing buildings within the determined working boundaries.

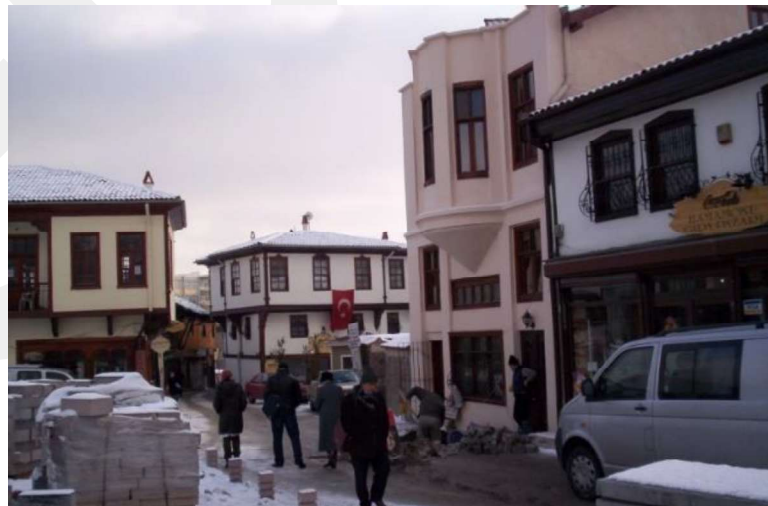
**Figure 122.** The Destroyed State of Kâmil Paşa Mansion,  
(Culture and Tourism Ministry, 2020)

In 1980, the mansion collapsed due to neglect, and then the mansion was demolished. By the Altındağ Municipality, the mansion was rebuilt in the same place in accordance with the original in the conservation works.

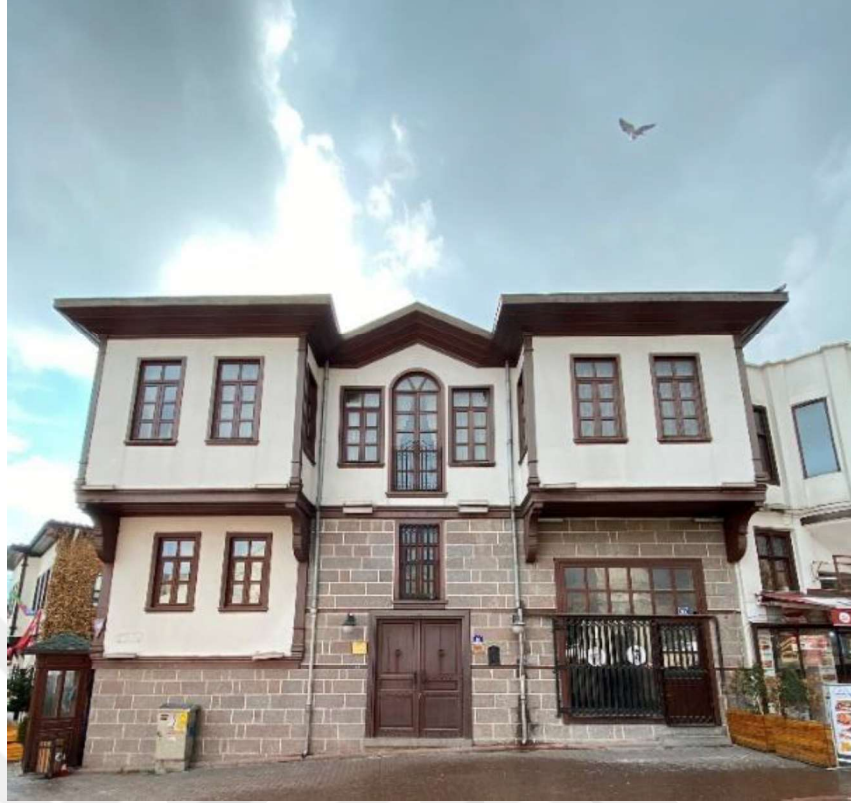
**Figure 123.** Kâmil Paşa Mansion, 2020

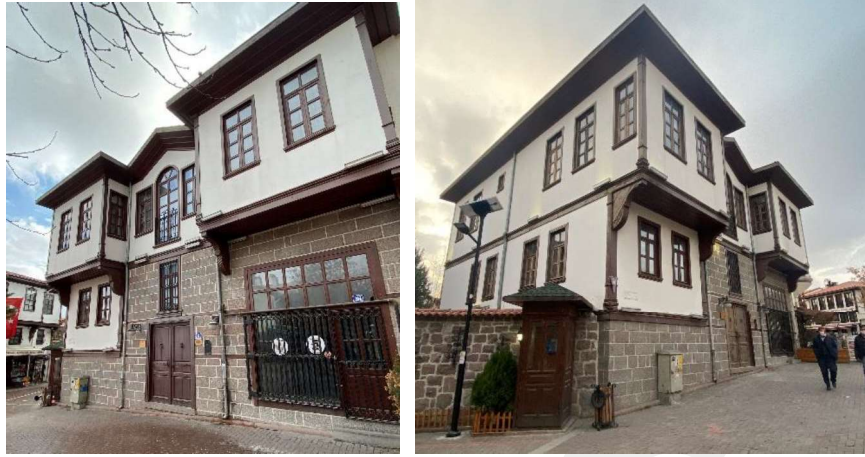
Kamil Paşa Mansion is in a better condition than other buildings when examined as interior space in the street rehabilitation project compared to other selected buildings. Wooden ceilings and ceiling hubs in the buildings are designed differently according to the importance of each room. However, the building doesn't fully comply with traditional building design details and there are new additions to the buildings. (Pişkin & Gökhan, 2021)

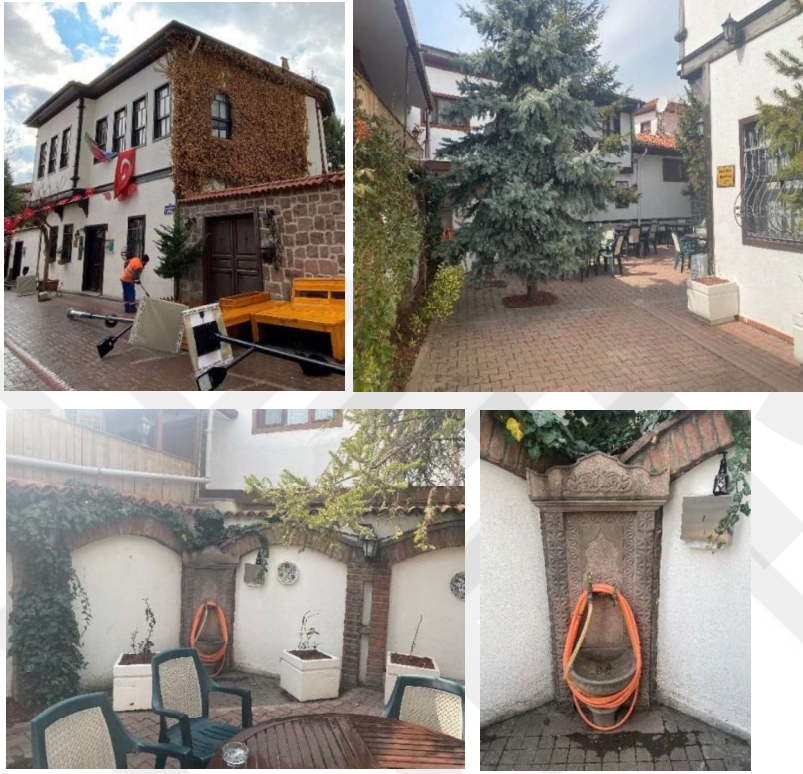
**Figure 157.** Gönüllerde Birlik Foundation Facade and Courtyard (Author's Archive, 2021)

Gönüller Birlik foundation is in a better condition than other buildings that are included in the street rehabilitation project. The building doesn't belong to the Altındağ municipality, it is a private building. In the courtyard of the building there is a fountain, which is one of the features of the traditional Turkish House. Wooden ceilings and ceiling hubs in the buildings are designed differently according to the
