**ADAPTIVE RE-USE OF HISTORICAL HERITAGE BUILDINGS:  
ASSESSMENT OF FOUR HAMAMÖNÜ HOUSES  
AND MORE EMPHASIS ON INTERIORS**

A THESIS SUBMITTED TO  
THE GRADUATE SCHOOL OF NATURAL AND APPLIED  
SCIENCES OF  
ÇANKAYA UNIVERSITY

IN PARTIAL FULFILLMENT OF THE REQUIREMENTS FOR THE  
DEGREE OF  
MASTER OF SCIENCE  
IN  
INTERIOR ARCHITECTURE  
DEPARTMENT

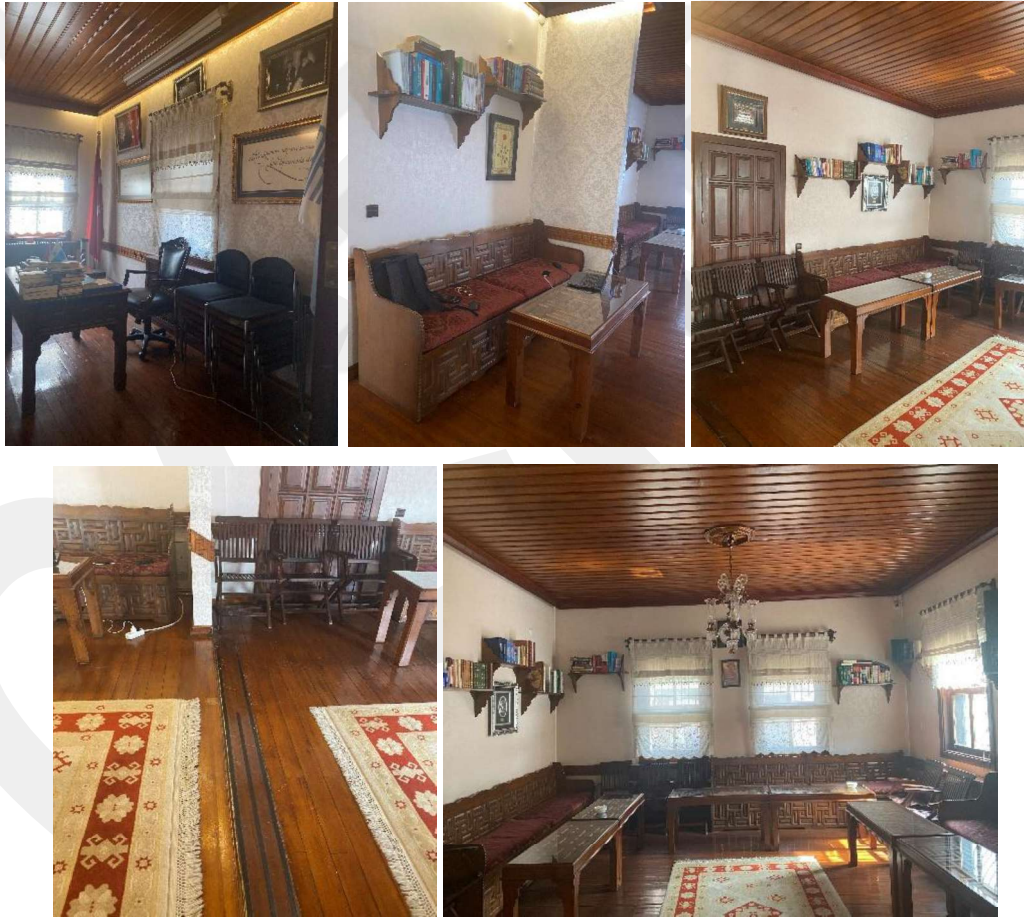
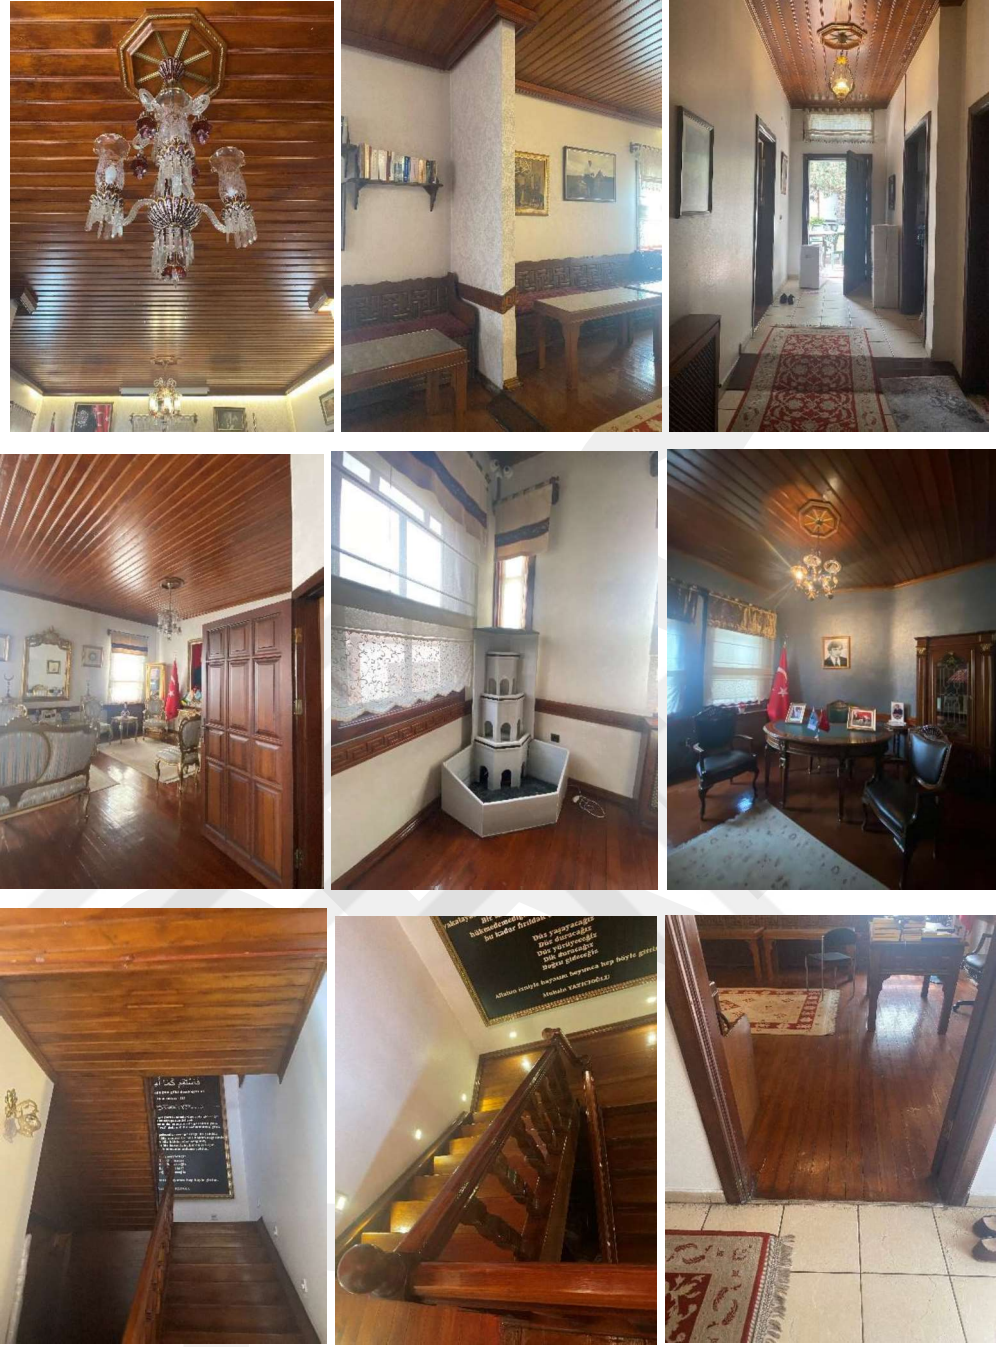
**Figure 159.** Gönüllerde Birlik Foundation Interior Images  
(Author's Archive, 2021)

In the interior of the building, unlike other buildings, the ramp function is provided by using small slopes in the ground transition places of the spaces and corridors. This situation wasn't encountered in any building in the region. The building was tried to be resolved within the universal design rules, but this was applied only on the ground floor. In the buildings, one of the features of the traditional Turkish House shelf, terek applications are seen. The building has wooden ceilings and ceiling cores.

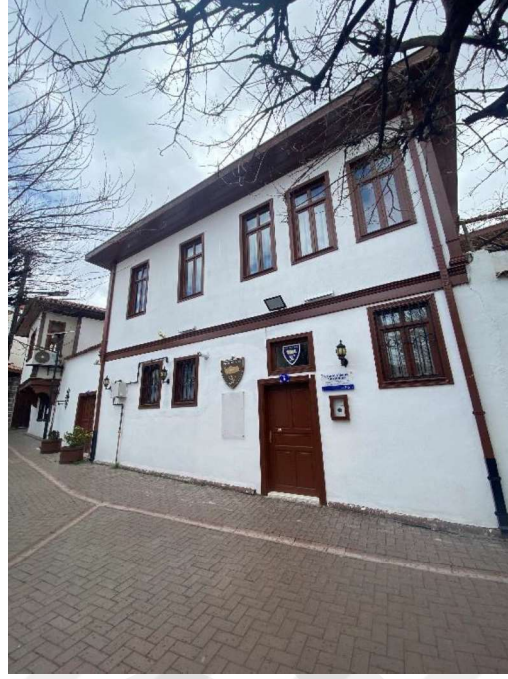
**Figure 165.** Siyasallılar Foundataion (Author's Archive, 2021)

The building contains multi-purpose halls within itself. It also has an oriental room and library. Interior architectural details bear significant reflections on the building from the past. However, some details (such as ceiling decorations) that can be seen in typical Turkish houses, some details have been evaluated as new interpretations. It loses its courtyard feature and functions as a warehouse. The ceiling embroidery in the largest room of the building draws attention. The courtyard, which existed before the restoration in the building, has been closed in the current building. It is designed in a modern way and closed with glass. It is used as a warehouse by making a cabinet inside. (Pişkin & Gökhan, 2021)

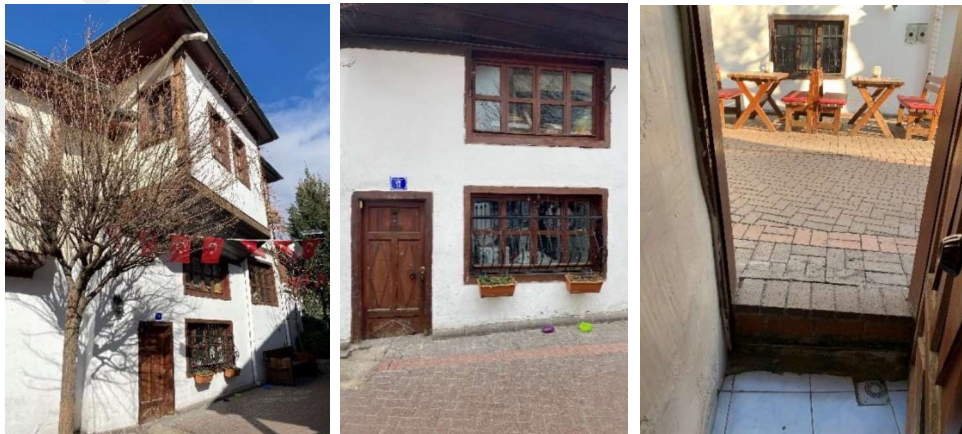
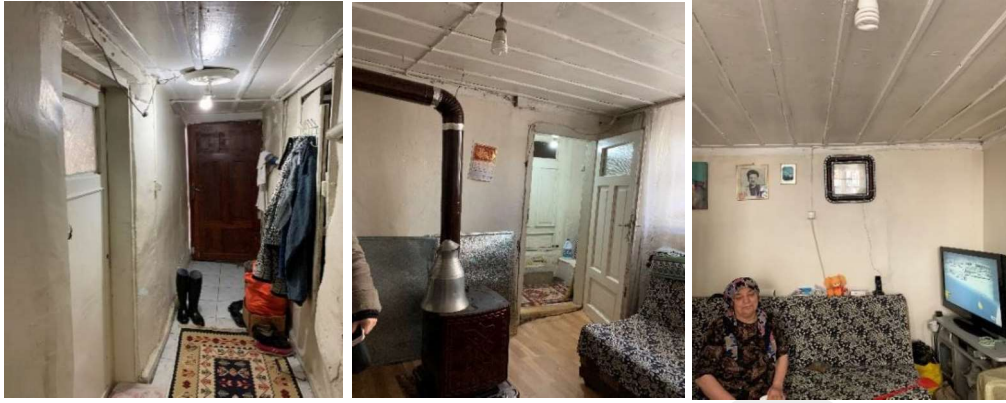
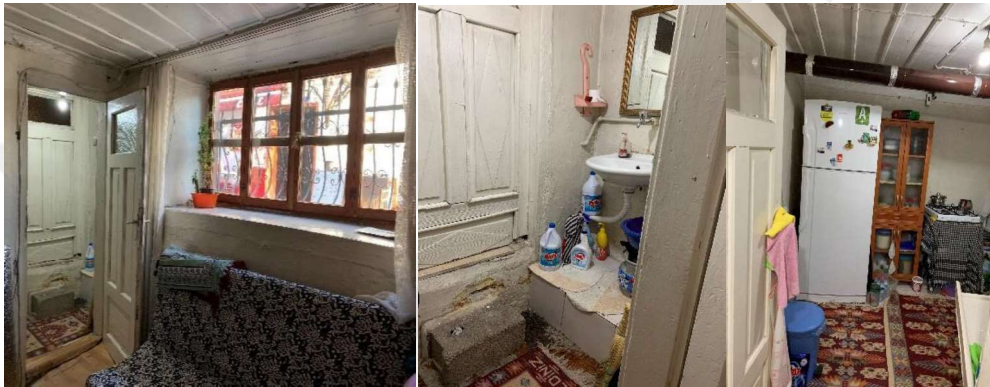
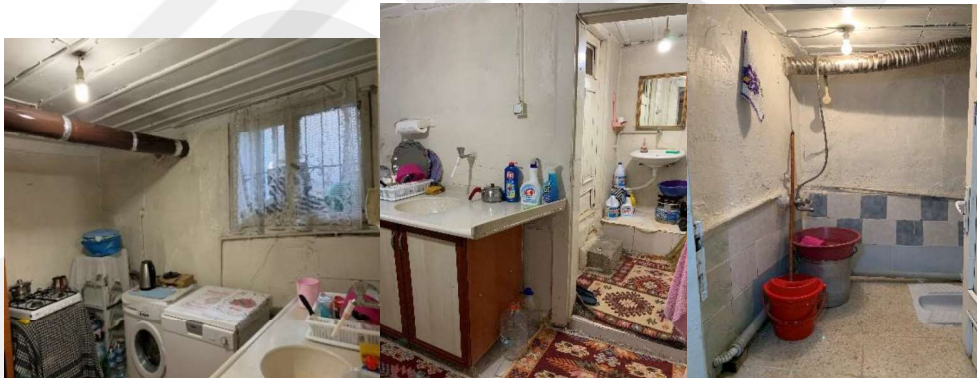
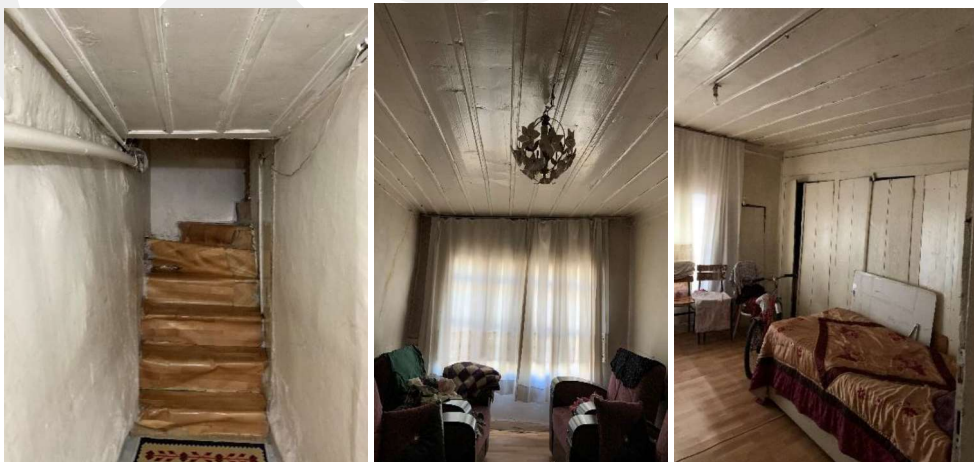
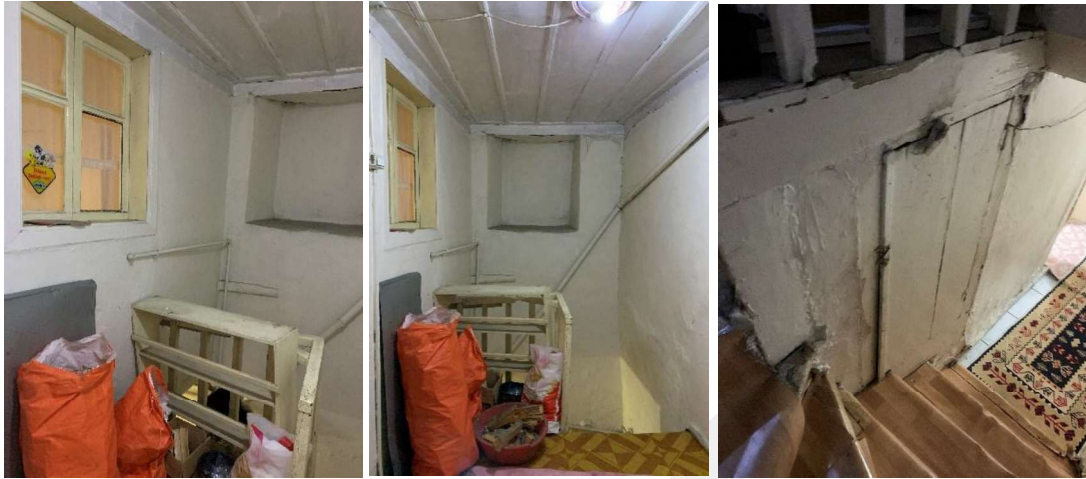
**Figure 167.** Mrs. Gülseren House Outdoor and Interior Images  
(Author's Archive, 2021)

Applications that took part in the construction Street Rehabilitation Project were provided, but there was no intervention in the buildings. Interior details are available in the buildings. Although there are households living in the buildings, the buildings has enough adverse conditions as use. It houses a cabinet/load rack inside the buildings. It is a buildings with under stair loads. Stove is used as heating. (Pişkin & Gökhan, 2021)

This buildings indicates the identity of the Turkish House. It conservation its identity as it hasn't been renewed much.

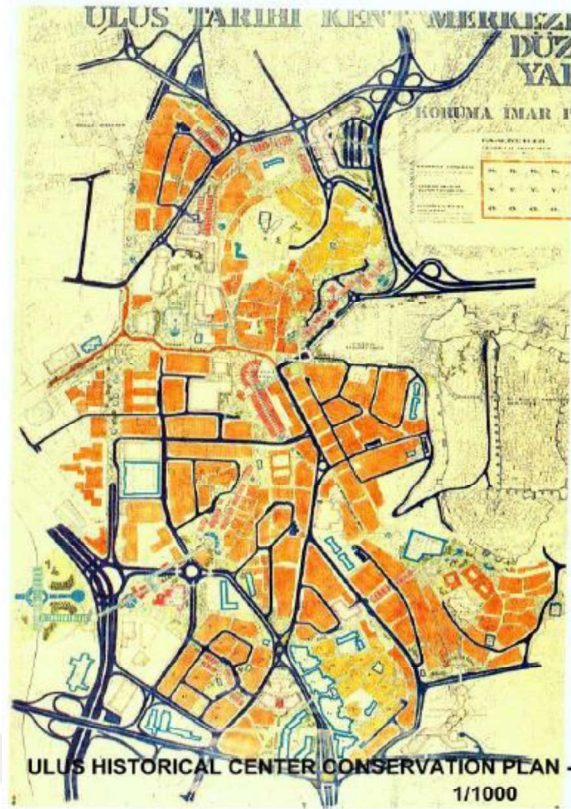
**Figure 185.** Canceled Ulus historic city center Conservation – Reclamation Zoning Plan (Ankara Castle Conservation Development Zoning Plan Project, 1987)

The first plan obtained for the Hamamönü region was approved in 1986 by the Ankara Metropolitan Municipality Zoning Department in the project ‘rehabilitation, protection, health and renovation of the Ulus historic city center’ thanks to the competition in 1986, but the project wasn't implemented. (Hazır, 2019)
